**Flood Control Project Maintenance
Levee Inspections**

Fall 2016 Levee Maintenance Deficiency Summary Report

Sacramento River Basin

NA0001	Overall LMA Rating	Total LMA Miles						
American River Flood Control District	A	34.47						
Rated Item	Maintenance Deficiency				Enforcement		Design & System Obsolescence	
	M Miles	U Miles	M + 4U Miles	Threshold %	M Miles	U Miles	M Miles	U Miles
<i>Earthen Levee</i>								
Vegetation	0.05		0.05	0.15%	0.73	0.38		
Encroachments					1.07	3.34		
Animal Control	0.02		0.02	0.06%				
Slope Stability	0.08		0.08	0.23%				
<i>Supplemental</i>								
2015 USACE Erosion Survey, DRAFT	0.04		0.04	0.12%				
DWR UCIP Field Study					0.96	0.07		
<i>LMA Totals:</i>	0.19	0.00	0.19	0.55%	2.76	3.79	0.00	0.00
Unit No. 01 Arcade Creek LB	Overall Unit Rating	Total Unit Miles						
NA0001	A	2.08						
Rated Item	Maintenance Deficiency				Enforcement		Design & System Obsolescence	
	M Miles	U Miles	M + 4U Miles	Threshold %	M Miles	U Miles	M Miles	U Miles
<i>Earthen Levee</i>								
Vegetation	0.01		0.01	0.48%	0.04	0.03		
Encroachments					0.30	0.27

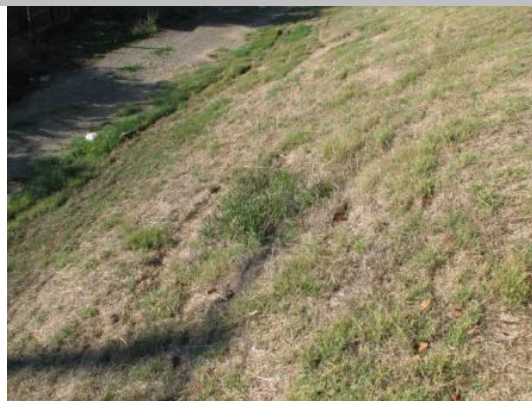
Photo 2 of 2 : FA_2016_NA0001_51_164_20160914_00052.jpg

11/17/2011 Hole/depression approximately mid-slope.

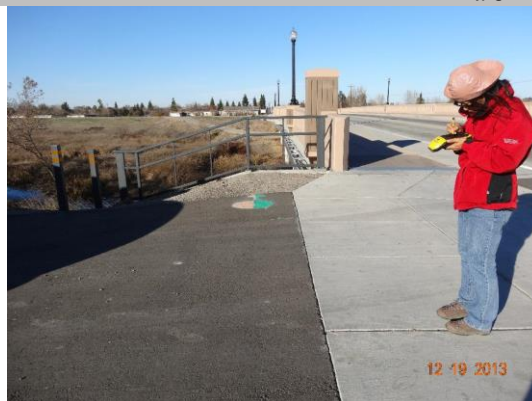
Photo 1 of 1 : UCIP_FA_2016_31169_57044.jpg

LM Start	0.66	Rating **	M	Issue No.	186
LM End	0.66	Issue Type +	En	Location *	LS
Category	Supplemental			GPS Latitude/Longitude	
				Start	End
Item	DWR UCIP Field Study			38.623668 °	38.623668 °
				-121.457156 °	-121.457156 °
DWR ID					
Comment Code					
Inspector Comment					
FS_ID:31169 DS_ID:24800 EP_NO: N/A Repair Type: Non-Urgent Crossing Status: Found UCIP Comments: Need to coordinate with the City of Sacramento to determine if structure (assumed indicated by green/orange symbol) crosses levee or symbol is referencing bridge. FIELD_STRUCT_DESC: Indicator of crossing found on waterward side edge. Symbol for Flood Control Structure (green/orange circle) was found during field inspection 12/19/13, symbol matches flood control structures that the City of Sacramento inspects. FS Date: 12/19/2013

Indicator of crossing found on waterward side edge. Symbol is a Flood Control Structure (green/orange circle).

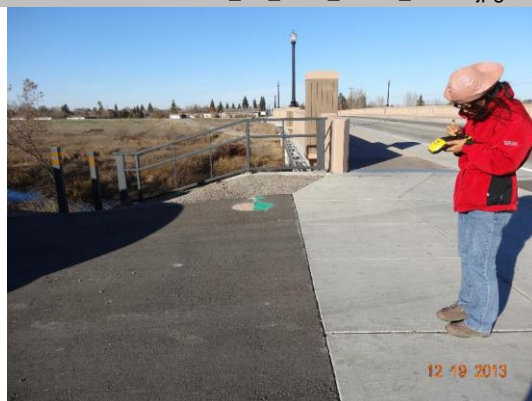
Photo 2 of 2 : UCIP_FA_2016_49930_57041.jpg

FS_ID:49930
DS_ID:24266
EP_NO: 3417
Repair Type: Urgent
Crossing Status: Found
UCIP Comments: 8/11/2016 Markers still missing. LMA representatives, Tim Kerr and Richard Marck, provided permit for 4-inch PG&E gasline to be raised to 200-year water surface elevation. Pipe will be modified on both the right and left bank. Elevation through the levee will need to be modified once pipe is raised through levee. (DWR UCIP - omagana)12/19/2013 no markers visible on waterward or landward side indicating this is a gas line--need to contact owner to determine if this crossing is gas line. (DWR UCIP - omagana)
FIELD_STRUCT_DESC: 4-inch steel gas line through the levee, 1.5 feet below the crown. Corrugated metal (CM) cutoff wall around pipe at the center of levee. Pipe hung along bridge across channel. 4-inch gate valve will be installed on the LS approximately 355 feet from levee crown (near Fairbanks Avenue and Norwood Avenue). (4-inch pipe installed under Permit No. 3417, 1961 - Pacific Gas and Electric Company [PG&E]; 4-inch pipe removed and replaced under Permit 18641, 2011 - PG&E; 4-inch pipe through levee (both right and left bank) raised above the 200-year water surface elevation under Permit No. 18641-1, 2016 - PG&E) [Additional Reference(s): DWR Levee Log, 2002]

Paint on paved levee indicates crossing could be a storm drain.

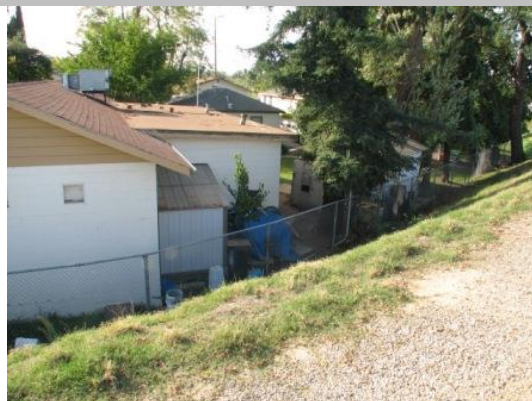
Photo 1 of 1 : FA_2016_NA0001_51_18_20160914_00016.jpg

Fall 2009 photo: Buildings and fence near levee toe.

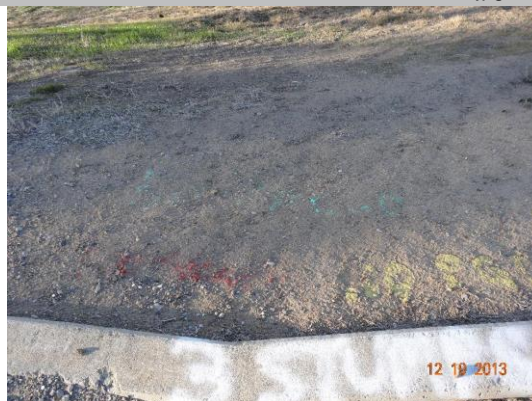
Photo 2 of 2 : UCIP_FA_2016_30085_55488.jpg

LM Start	1.28	Rating **	M	Issue No.	184 (cont)	
LM End	1.28	Issue Type +	En	Location *	LS	
Category	Supplemental			GPS Latitude/Longitude		
				Start	End	
Item	DWR UCIP Field Study			38.625500 °	38.625500 °	
				-121.446390 °	-121.446390 °	
DWR ID						
Comment Code						
Inspector Comment						
FS_ID:30085 DS_ID:24576 EP_NO: N/A Repair Type: Non-Urgent Crossing Status: Indicator Found UCIP Comments: Unable to confirm location--will need to coordinate with owner to determine if crossing is still active and determine location. FIELD_STRUCT_DESC: 1 of 3: 16-inch pipe through the levee, 8.0 feet below the crown. Floodgates within the levee across the channel, installed under Permit No. 14480 (1986). FS Date: 12/19/2013

Underground service alert (USA) paint markings visible on waterward slope.

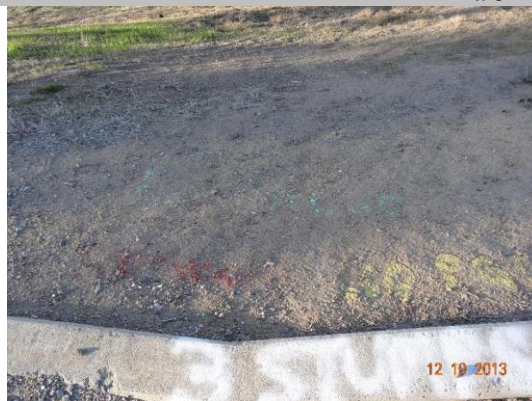
Photo 2 of 2 : UCIP_FA_2016_29732_54975.jpg

LM Start	1.28	Rating **	M	Issue No.	185 (cont)	
LM End	1.28	Issue Type +	En	Location *	LS	
Category	Supplemental			GPS Latitude/Longitude		
				Start	End	
Item	DWR UCIP Field Study			38.625500 °	38.625500 °	
				-121.446390 °	-121.446390 °	
DWR ID						
Comment Code						
Inspector Comment						
FS_ID:29732						
DS_ID:24577						
EP_NO: N/A						
Repair Type: Non-Urgent						
Crossing Status: Indicator Found						
UCIP Comments: Unable to confirm location--will need to coordinate with owner to determine if crossing is still active and determine location.						
FIELD_STRUCT_DESC: 2 of 3: 6-inch pipe through the levee, 8.0 feet below the crown. Flap gate on the waterside (WS) end. Floodgates within the levee across the channel, installed under Permit No. 14480 (1986).						
FS Date: 12/19/2013

Underground service alert (USA) paint markers visible on waterward shoulder--unable to confirm type of crossings.

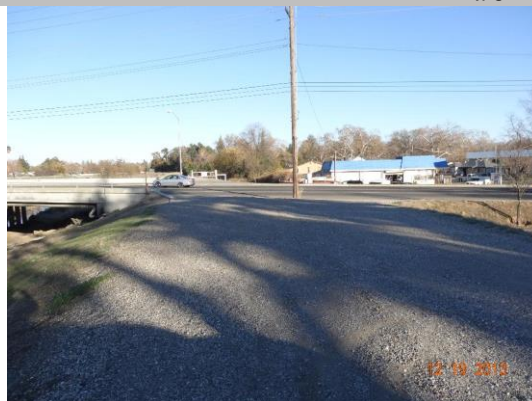
Photo 1 of 2 : UCIP_FA_2016_49932_75855.jpg

Comment Code					
Inspector Comment					
FS_ID:49932 DS_ID:24252 EP_NO: 15152 Repair Type: Urgent Crossing Status: Indicator Found UCIP Comments: 8/11/2016 Markers still missing. Unable to confirm if line will be raised to 200-year water surface elevation at this site. (DWR UCIP - omagana)12/19/2013 Need to confirm if this crossing is gas line. Need to contact owner to determine status of crossing (active or inactive) and to determine last inspection date. Will need copy of letter showing crossings passed inspection. Missing utility markers. (DWR UCIP - omagana) FIELD_STRUCT_DESC: 4-inch steel gas main through the levee, 2.5 feet below the crown. Vent on the waterside (WS) shoulder. Unable to confirm if crossing will be raised to 200-year water surface elevation within Unit 1. (4-inch gas line installed under Permit No. 15152, 1989 - Pacific Gas & Electric Company [PG&E], 4-inch gas line raised above the 200-year water surface elevation under Permit No. 15152-1, 2016 - PG&E) [Additional Reference(s): DWR Levee Log, 2002] FS Date: 8/11/2016

View of levee crown where crossing should be--no markers found.

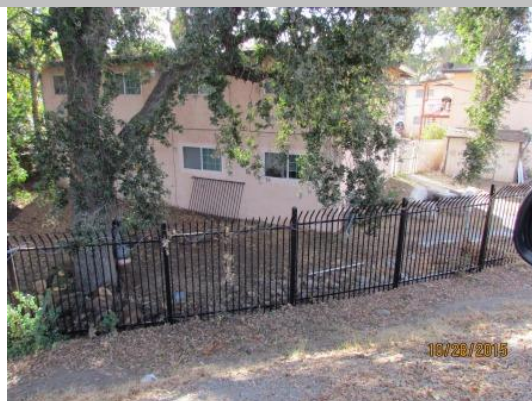
Photo 1 of 1 : FA_2016_NA0001_51_70_20160914_00044.jpg

View of the fence at the landside levee toe.

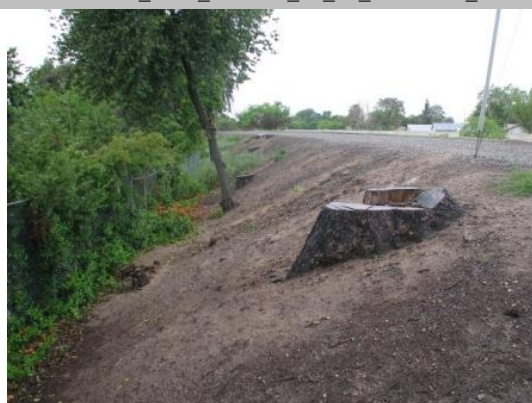
Photo 1 of 1 : FA_2016_NA0001_51_56_20160914_00035.jpg

Several large stumps on levee slope.

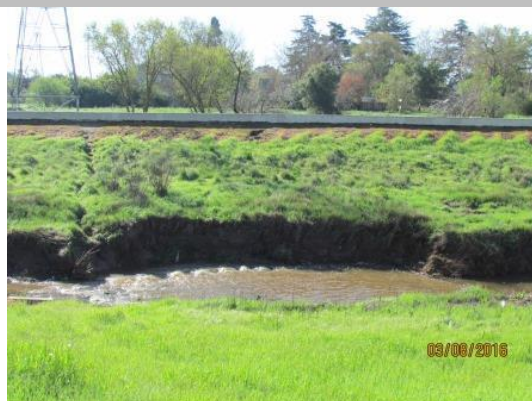
Photo 1 of 1 : FA_2016_NA0001_51_84_20160914_00050.jpg

LM Start	1.74	Rating **	A/W	Issue No.	84
LM End	1.74	Issue Type +	Ma	Location *	WS
Category	Earthen Levee			GPS Latitude/Longitude	
				Start	End
Item	Erosion / Bank Caving			38.627846 °	38.627846 °
				-121.438641 °	-121.438641 °
DWR ID	DWR_NA0001_01_s_2016_84				
Comment Code					
E1 : Note and monitor erosion site.					
Inspector Comment					
The LMA is making plans to repair this site soon. Erosion has not progressed as of Fall 2016.

View of the erosion on the waterside levee berm.

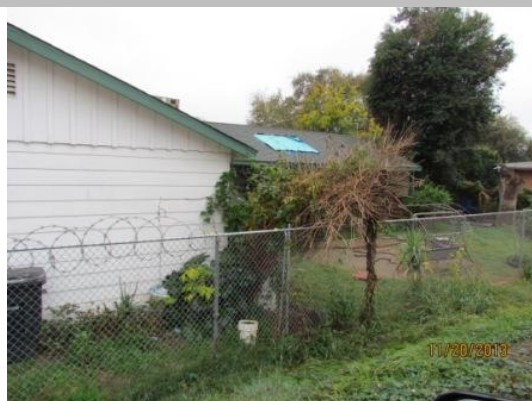
Photo 1 of 1 : FA_2016_NA0001_51_1_20160914_00001.jpg

View of the fence and landscaping at the landside levee toe.

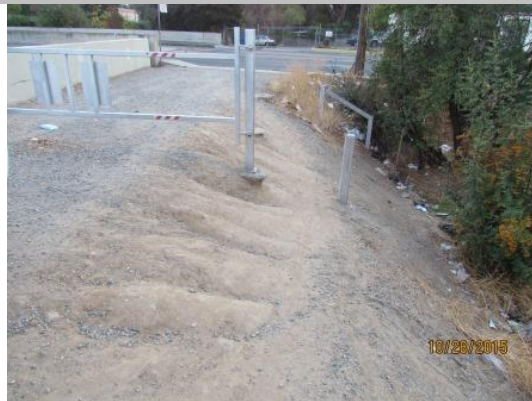
Photo 1 of 1 : FA_2016_NA0001_51_46_20160914_00029.jpg

View of the damaged landside levee slope.

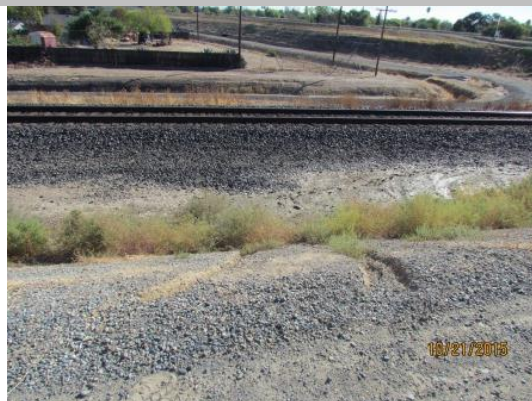
Photo 1 of 1 : FA_2016_NA0001_52_26_20160914_00006.jpg

View of the damaged landside levee slope.

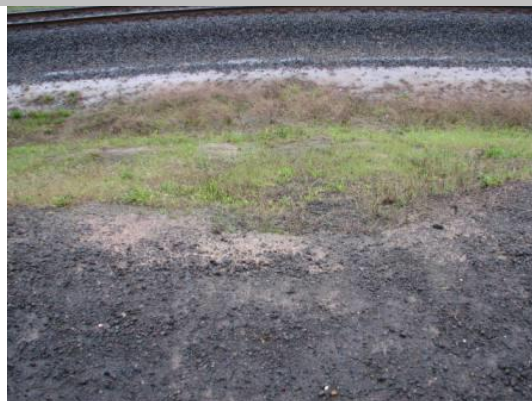
Photo 1 of 2 : FA_2016_NA0001_52_150_20160914_00009.jpg

03/14/2012 Photo shows depression, the issue has not gotten any worse since the fall 2011 inspection.

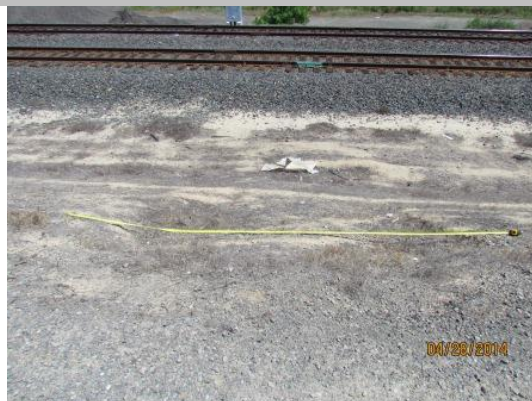
Photo 1 of 1 : FA_2016_NA0001_52_6_20160914_00002.jpg

View of landside slope instability.

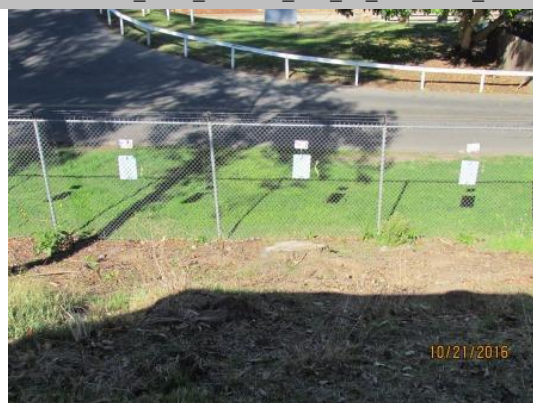
Photo 1 of 1 : FA_2016_NA0001_490_22_20161031_00036.jpg

View of the tree stump on the landside levee slope.

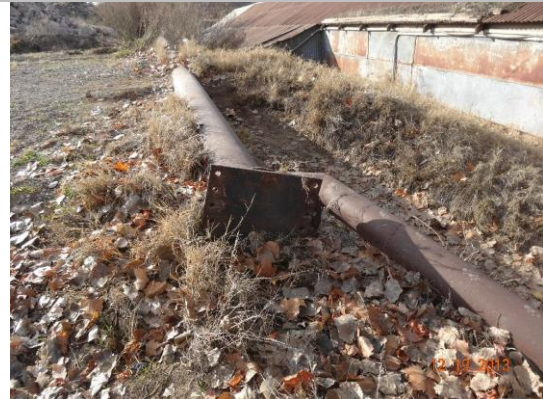
Photo 1 of 2 : UCIP_FA_2016_29944_55267.jpg

Remnants of old crossing located on levee crown.

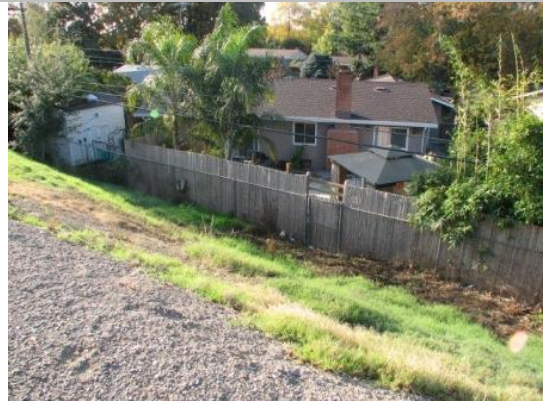
Photo 2 of 2 : FA_2016_NA0001_55_8_20160914_00010.jpg

Fall 2009 photo: Fence and landscaping within 10-ft of levee toe obstructs access and visibility.

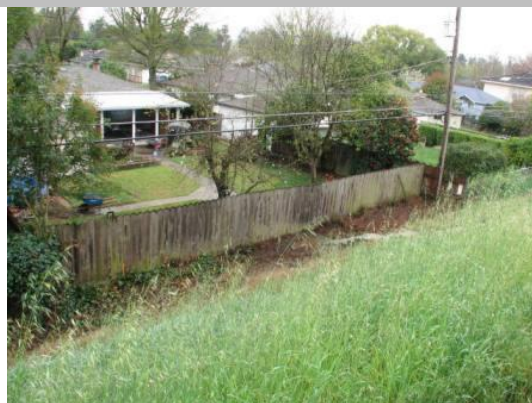
Photo 1 of 1 : FA_2016_NA0001_55_35_20160914_00032.jpg

03/16/2012 Wood privacy fence completely obstructs access and visibility.

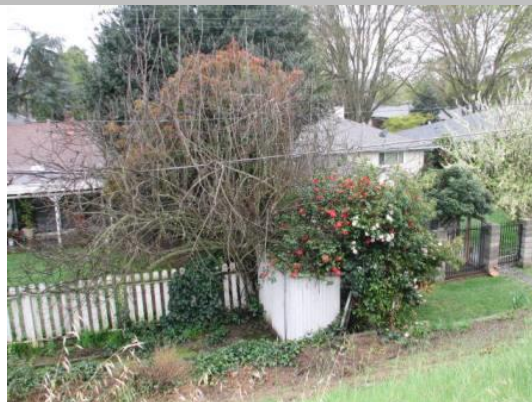
Photo 1 of 1 : FA_2016_NA0001_55_206_20160914_00173.jpg

03/16/2012 Landscaping obstructs visibility and access.

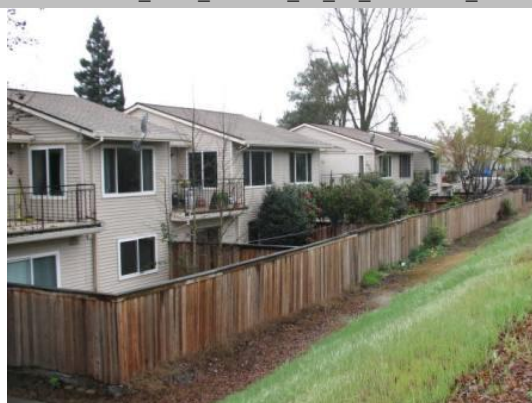
Photo 1 of 1 : FA_2016_NA0001_55_76_20160914_00060.jpg

03/16/2012 Wood privacy fence completely obstructs access and visibility.

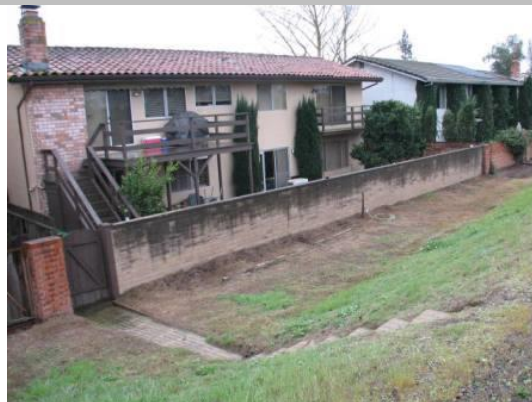
Photo 1 of 1 : FA_2016_NA0001_55_83_20160914_00067.jpg

03/16/2012 Brick wall completely obstructs access and visibility.

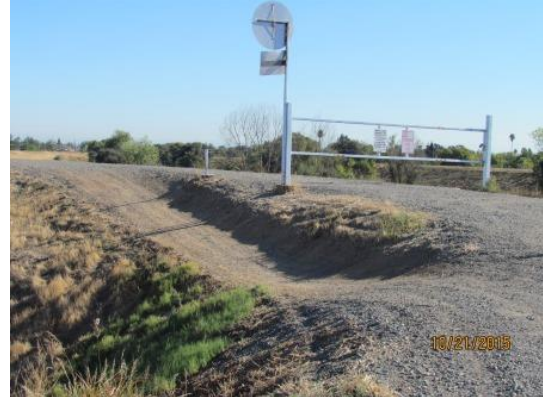
Photo 1 of 1 : FA_2016_NA0001_58_38_20160914_00031.jpg

View of the landside levee slope damaged by motorized traffic.

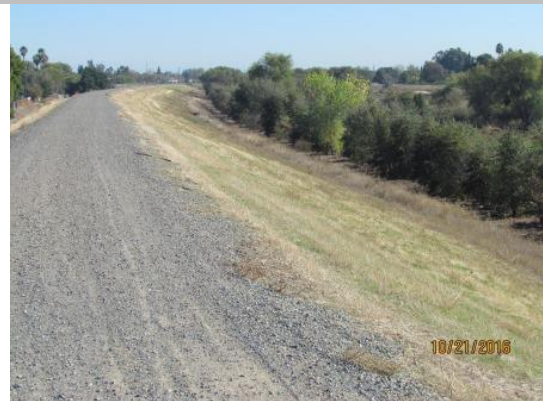
Photo 1 of 1 : FA_2016_NA0001_58_36_20161031_00049.jpg

View of the vegetation on the waterside levee slope.

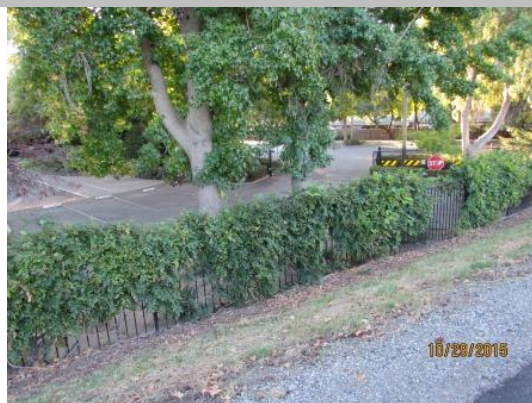
Photo 1 of 1 : FA_2016_NA0001_60_24_20160914_00005.jpg

View of the vines on the fence at the landside levee toe.

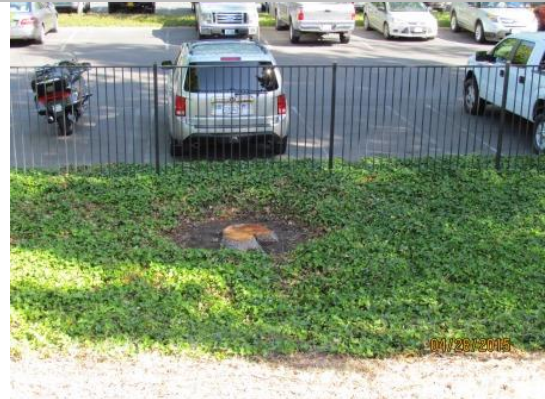
Photo 1 of 1 : FA_2016_NA0001_61_23_20160914_00006.jpg

View of the tree stump at the landside levee toe.
